Home Inspection Report

1234 example, Anywhere, WI 53051

Monday October 30, 2017

Hearthstone Home Inspections, LLC
(262) 366-3565

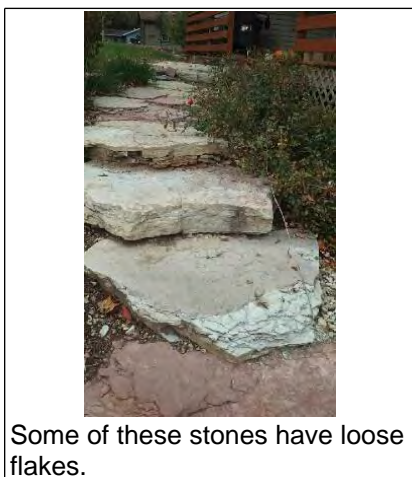
Comments The walk up to the front steps is a series of stone slabs, and the walkway consist of flagstones. While this is appropriately rustic for this property, in my opinion it does constitute a series of trip hazards, and there is really no alternative way to get into the house. I recommend you consider installing more traditional steps and railings.

Some of these stones have loose flakes.

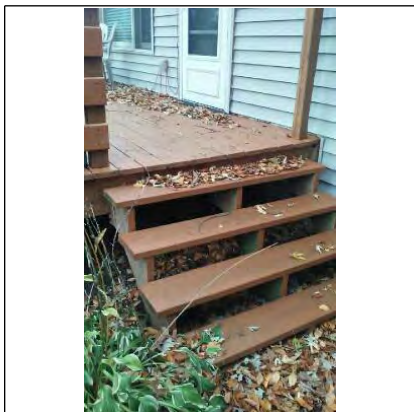
Comments -I recommend adding a handrail to the back steps.

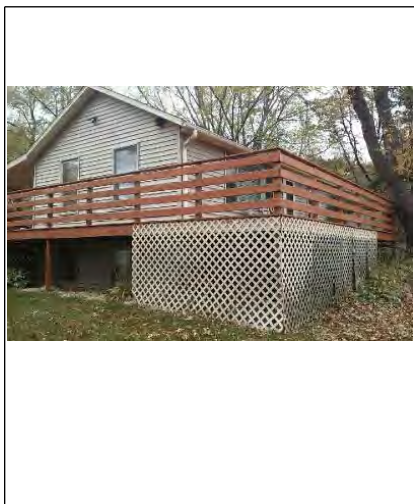
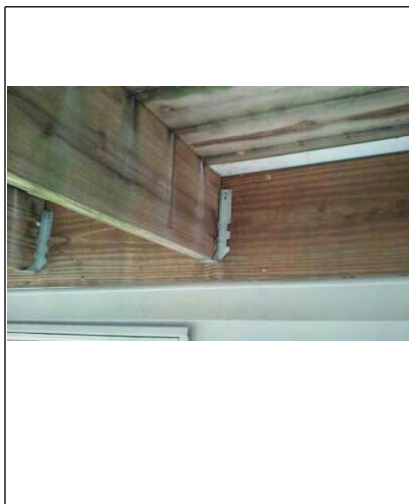
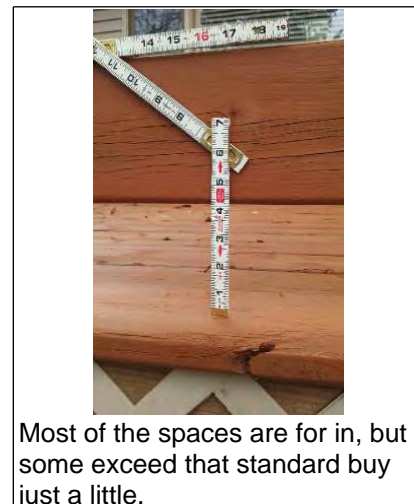
Comments -Joist hangers were appropriately used for most of the joists to fasten them to the ledger board.

Most of the spaces are for in, but some exceed that standard buy just a little.

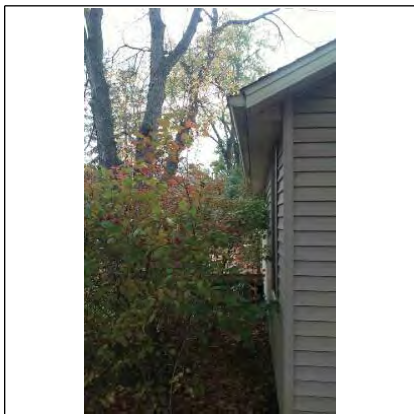
- Recommend maintaining a positive drainage slope away from the foundation.
- Low areas of grading next to the foundation recommend adding additional soil and slope away from foundation.
- Recommend trimming trees/vegetation so it does not come into contact with the home.
- Trees that extend above the roof presents some risk that they may drop leaves, seeds, and limbs onto the roof, either causing damage or clogging gutters. Dead branches, aggressive growth, and any actual contact with the structure should be trimmed back. Other than that, you should weigh the potential for problems against the aesthetic value of the trees.

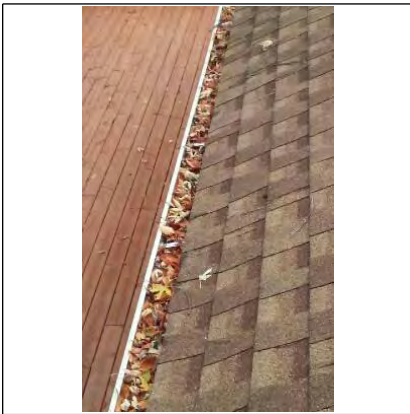
- None
Condition Satisfactory Marginal Poor Rusting Downspouts needed Recommend repair/replace
 Needs to be cleaned
Material Copper Vinyl/Plastic Galvanized/Aluminum Other: .
Leaking Corners Joints Hole in main run No apparent leaks
Attachment Loose Missing spikes Improperly sloped Satisfactory
Extension needed North South East West N/A
Comments -Gutters on only a portion of the house, recommend additional gutters where needed.
 -The insides of the gutters are full of debris - recommend cleaning.

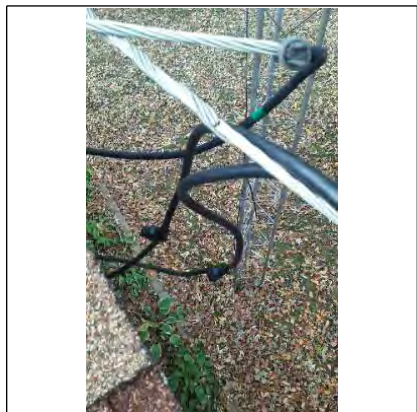
Comments The clamps on the service conductors near the Masthead are a type that are considered appropriate only for temporary use. I recommend contacting the utility to see about having permanent connectors installed.

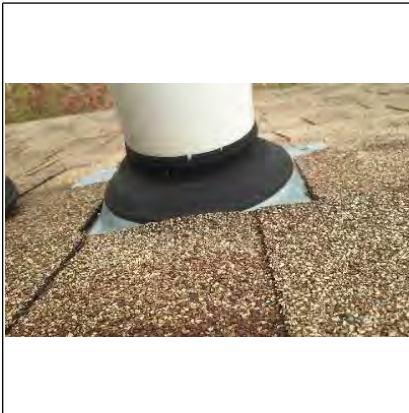
Comments The rubber flashings around the plumbing stacks have split and should be replaced or covered, preferably with a product that does not require damage to the roof covering.

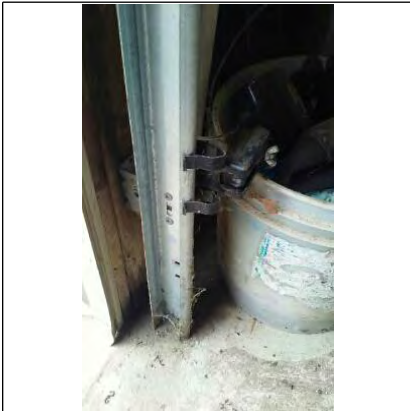
Comments -Electric eyes at the base of the garage door too high above the floor, potential safety hazard. Recommend 6" from floor.

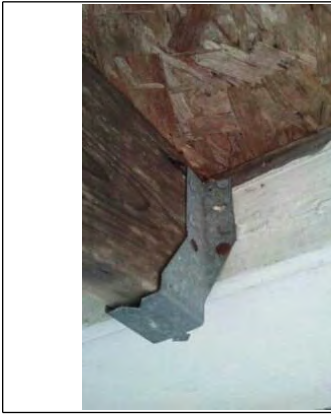
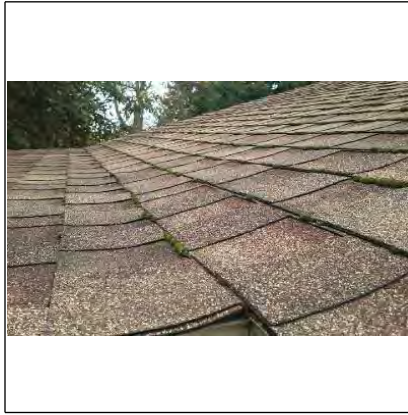
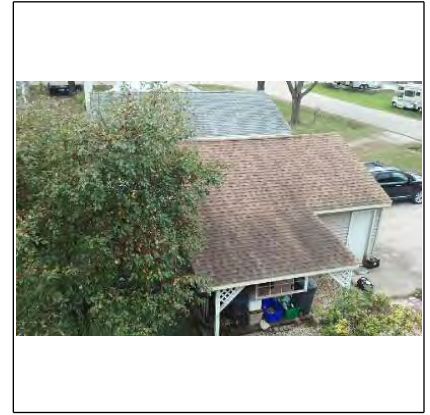
Comments I recommend monitoring the extended roof on the garage for any looseness or water damage. The slope on this roof is lower than what is recommended for asphalt shingles, and the rafters are hung with joist hangers that are secured with roofing nails instead of the proper fasteners.

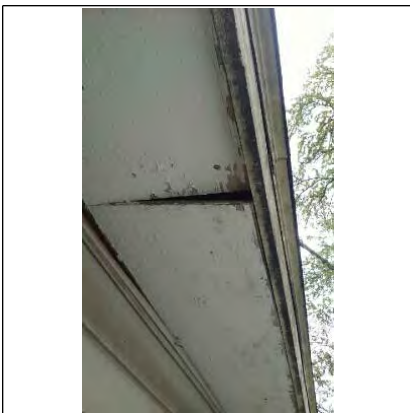
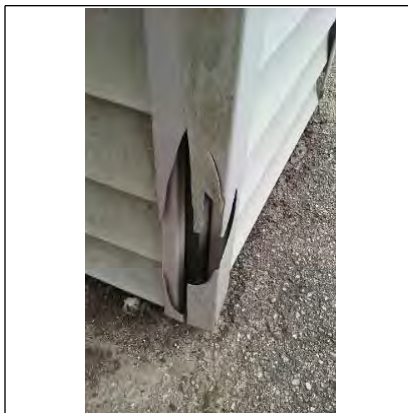
Comments -Garage trim had some damage - recommend repair.
There is an opening in the soffit that would be an invitation for pests.

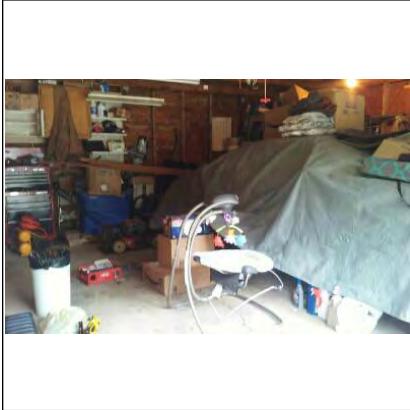
Comments -The garage floor has significant cracks. They are too large to be ignored but may not yet warrant replacing the floor. You can expect them to continue to get worse and eventually the floor will need to be replaced.

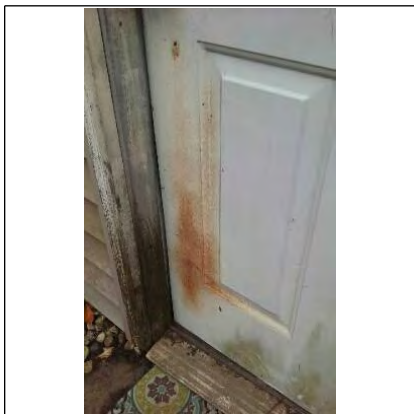
Comments -I recommend repainting the service door to the garage.

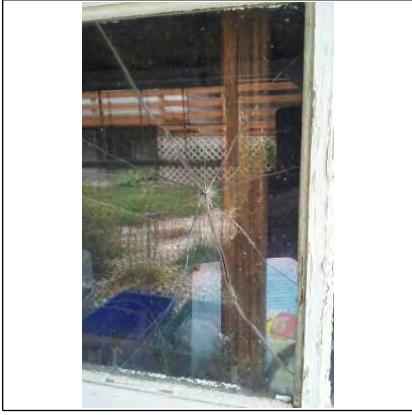
Comments: I recommend the broken window on the garage be repaired or replaced.

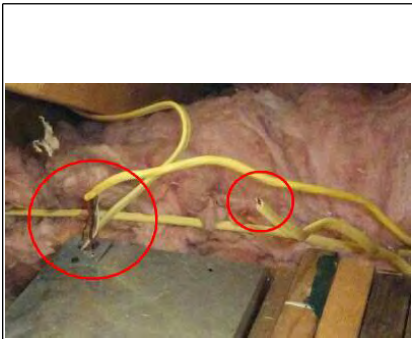
Comments: Above one of the bath fans in the Attic, there is some wiring that is not properly secured inside an enclosed box, and also there is a bare energized conductor in this area. I recommend a qualified electrician repair.

Energized bare conductor on the right, and unprotected conductors on the left

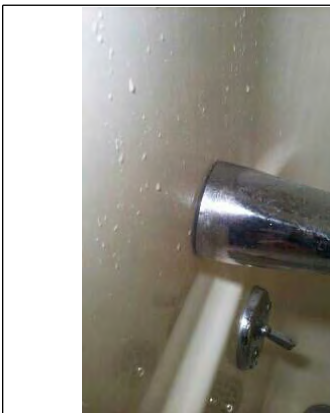
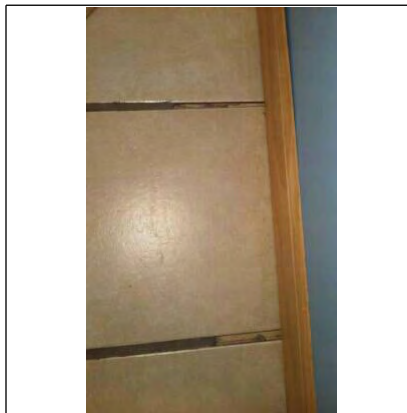
Comments -Recommend caulking the tub facet in the hall bathroom.
-Recommend grouting the open gaps in the floor tile behind the door in the hall bath.

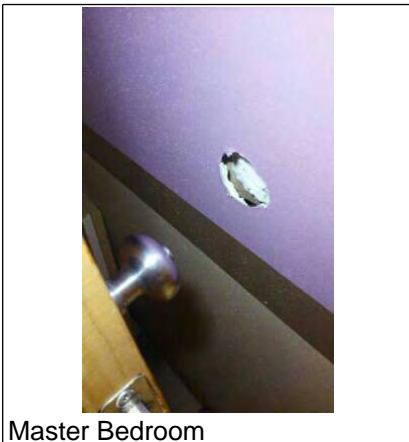
Comments -There was a hole in the wall in the master bedroom - recommend repair.

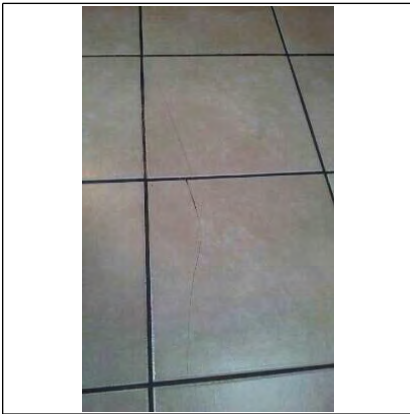
Comments -There were 2 cracked tiles in the living room close to the basement stairs - recommend replacement.

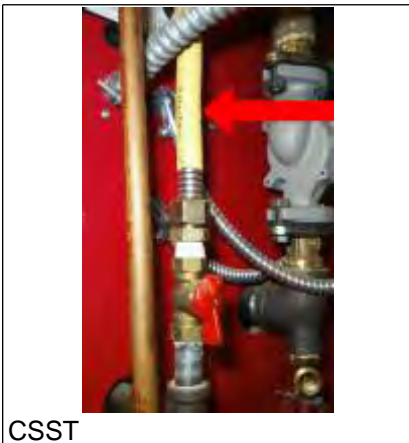
Comments -CSST (Corrugated Stainless Steel Tubing). it is a flexible line covered with a usually yellow plastic sheath. it is generally an acceptable material. However, since its introduction, there have been manufactures' bulletins, and I have been informed there is a code change directing that the CSST line must be directly bonded to an electrical ground. Such a bonding wire was not seen in the inspection, and you should have a qualified electrician install one in accordance with local codes.

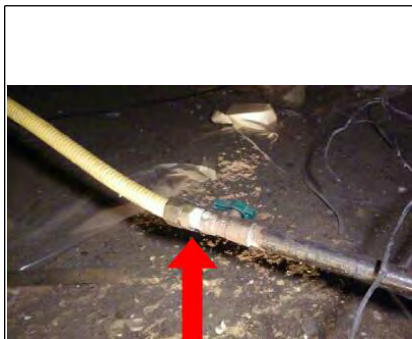
Comments One or more gas leaks were detected with the aid of a combustible gas detector. They are described and marked with yellow tape. One of the gas leaks is at the drip tube for the boiler, and the other one is in the crawl space where the csst joins the solid pipe. I recommend these be repaired by a qualified plumber.

Gas leak at this location

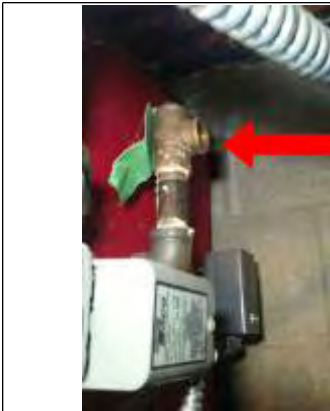
There should be an extension tube here.

I recommend there be an extension tube on the tpr valve on the boiler. Also, the extension tube from the check valve was leaking water and I recommend this be evaluated by a qualified HVAC technician when the boiler is serviced.

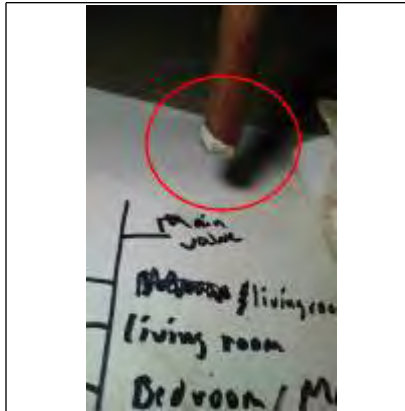
A small amount of water was dripping from this tube.

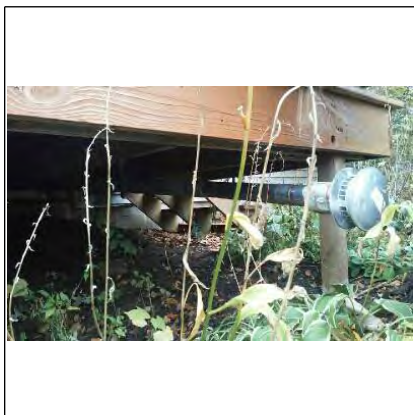
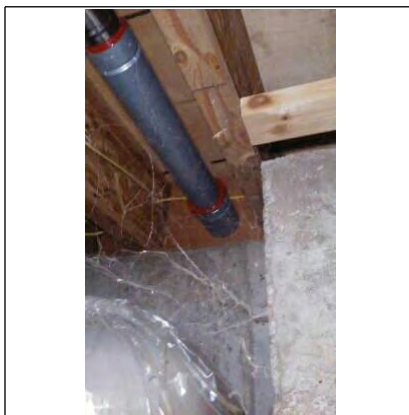
Comments: The exhaust pipe for the boiler runs out the side of the house beneath the deck. I believe there are some issues with this arrangement. First, there is no fire collar where the pipe passes through the rim joist. Second, it runs downhill, whereas any type of Chimney should always run uphill. Third, it terminates near ground level at the edge of the deck. This pipe can get very hot and also would be giving off exhaust right below where people might be sitting on the deck and there could be a carbon monoxide issue. This boiler can run all year long to heat the water. I recommend when the boiler is serviced, that this exhaust arrangement be evaluated.

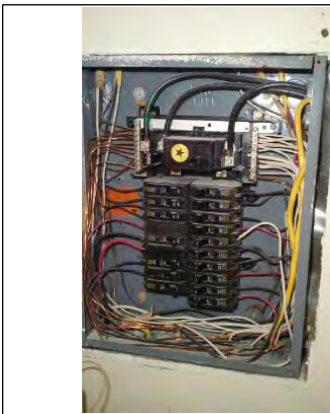
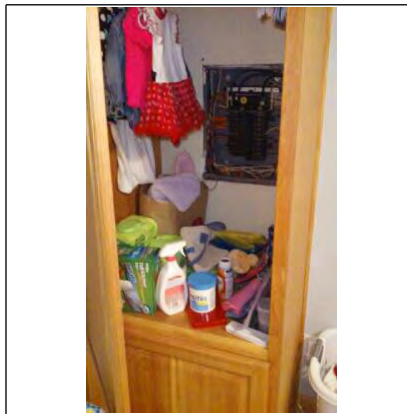
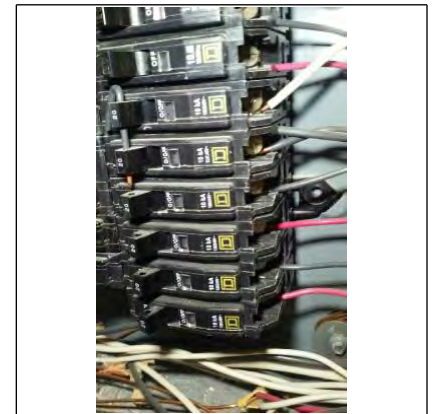
-Improper clearance to the electric panel - there is supposed to be 36 inches clearance to the front of the panel and a total of 30 inches to the sides (adding the two sides together). That is not the case here.

Comments Branch wires are under sized - Recommend licensed electrician repair and/or replace as necessary. One of the 30 amp Breakers in the Left Bank of circuits appears to have 12 gauge conductors attached.
 -Improper clearance to the electric panel - there is supposed to be 36 inches clearance to the front of the panel and a total of 30 inches to the sides (adding the two sides together). That is not the case here.
 These Breakers do not appear to be the type that are approved for double tapping. On the right Bank of circuits two 20 amp Breakers have been tied together to create a double pole, however one of the breakers has two conductors on it which would appear to unbalance the circuit. When you have an electrician on the premises. I recommend you ask him or her to correct this situation.
