Home Inspection Report

1234 example, Anywhere, WI 53051

Monday October 30, 2017

Hearthstone Home Inspections, LLC
(262) 366-3565

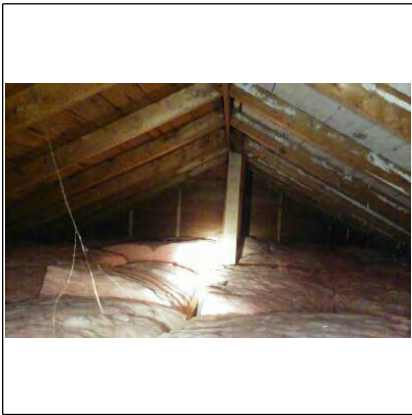
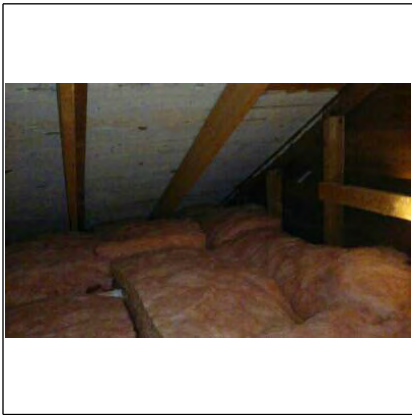
Attic

Comments: Above one of the bath fans in the Attic, there is some wiring that is not properly secured inside an enclosed box, and also there is a bare energized conductor in this area. I recommend a qualified electrician repair.
